Legal Description	SCT: 08 T:32 N R: 16 E LOT: 015 BLK: 008; S 62.84 FT of LTS 15-17, S 62. 84 FT of W Site: 24HL1307	
Address	128 (126) Third Avenue	
Current Owner	Two JD's Rental LLP	
Private	Current Owner Address	213 Third Ave, Havre, MT 59501-3520
🗌 NAD 83 🗹 I	NAD 27	Historic Name Chestnut Building
Zone: ## Easting	g: 597564 Northing: 5378368	Common Name Havre Montana Realty- 128, Wolfer's- 126
Moved? 🖌 E	stimated Documented	Date of Construction 1910 Estimated
Date of Move:		
Quad Name:		Building Changes 1953
Footprint:		Architect

Statement of Significance

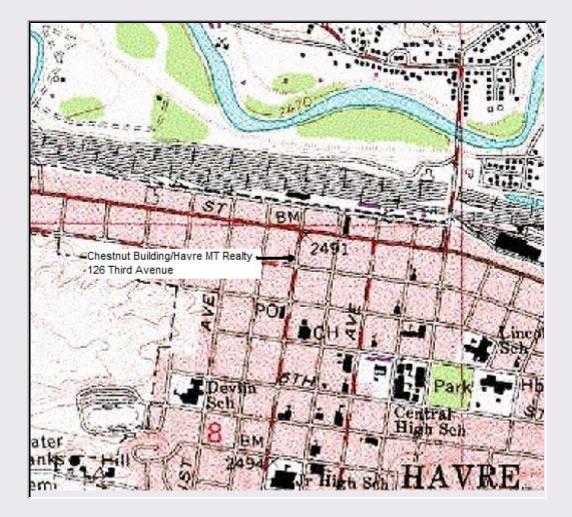
Picture:

-	NER	Builder
	The second se	Original Owner B. Frank Chestnut
	VRE HT	Original Use bank, retail, meeting hall, rooms
		Present Use offices, restaurant
	22.000	Foundation: Stone
	<u> </u>	Exterior Walls: Brick
		Roof: Composite
		Other Materials:
Bibliography Tax Records, Hill County Courthouse; Sewer and Water Permits, Public Works, Havre		
Havre Hill County Library: Grits, Guts, and Gusto. A History of Hill County.		
Po	olk Directories and Sanborn Fire I	nsurance Maps,
	ary Wilson's private collection.	he Plaindealer, various years.; The Promoter, various years.; The Havre Daily Promoter, various years.
Physical The building at 126 Third Avenue is a two-story, red, stretcher course brick building joining the Petroleum Building. It has a m Description and glass commercial storefront with offset and inset entrance, sidelights, and windows. A wooden canopy extends across the		h offset and inset entrance, sidelights, and windows. A wooden canopy extends across the façade of this

su	and the building to the south at 128 Third Avenue. There are three windows at the second story that have sandstone sills, brick header surrounds, and are infilled with wood. The windows are emphasized by a slightly projecting window bay with stretcher bands of brick that arch	
		n inset header-brick, half-circle is located within the arch. The stretcher band and arch are capped in have inset header brick that gives the building the appearance of increased height.
At	128 Third Avenue is a two-story	stretcher and header course brick building that faces east onto Third Avenue and joins the building at 126.
		treatment as in 126. The entrance here is inset with sidelights, a two-light box showcase and five-light or is at the base. The glass band of transoms above the entrance has been infilled with wood as has been
	done at 126 Third Avenue. The canopy on this end is wooden clad. Brick bands under the second story windows are corbelled and the windows are two sets of replacement, paired three-light single-hungs. Brick voussoirs are above the windows. There is a band of brick corbelling with pendants near the cornice. Each side of the front, east façade has pilasters and the south end facing Second Street has five bays divided by pilasters. At the first story, the windows are infilled while windows at the second story are the same as at the front façade.

CO		
		e same brick detail is visible on the south elevation as well as a ghost sign "Lindelow's Drug Store".
Significance th	ne Chestnut Block was constructe	reet North on the westside were purchased for \$7500 by the B. Frank Chestnut family and it was here that d near a cost of \$16,000. B. Frank came to Havre in 1893 after spending time in North Dakota and Cut
St		in the saloon business. He bought several properties in Havre and operated a fashionable saloon on First hat served wine, whiskey, and beer. He was in the tavern business until 1908 when he began investing in
		State Bank on the first floor, and was designated as the Chestnut Hall upstairs and served the congregation
or	rganizations were housed in this	Mark's was constructed. In the 1910s, several fraternal orders such as the Eagles and Elks, and labor building which was purchased by the Lindelow family in 1929. They operated a drugstore at 128 Third
